OH-6A

ACCIDENT SUMMARY

OH-6A ACCIDENT SUMMARY

1 February 1965 through 30 June 1967

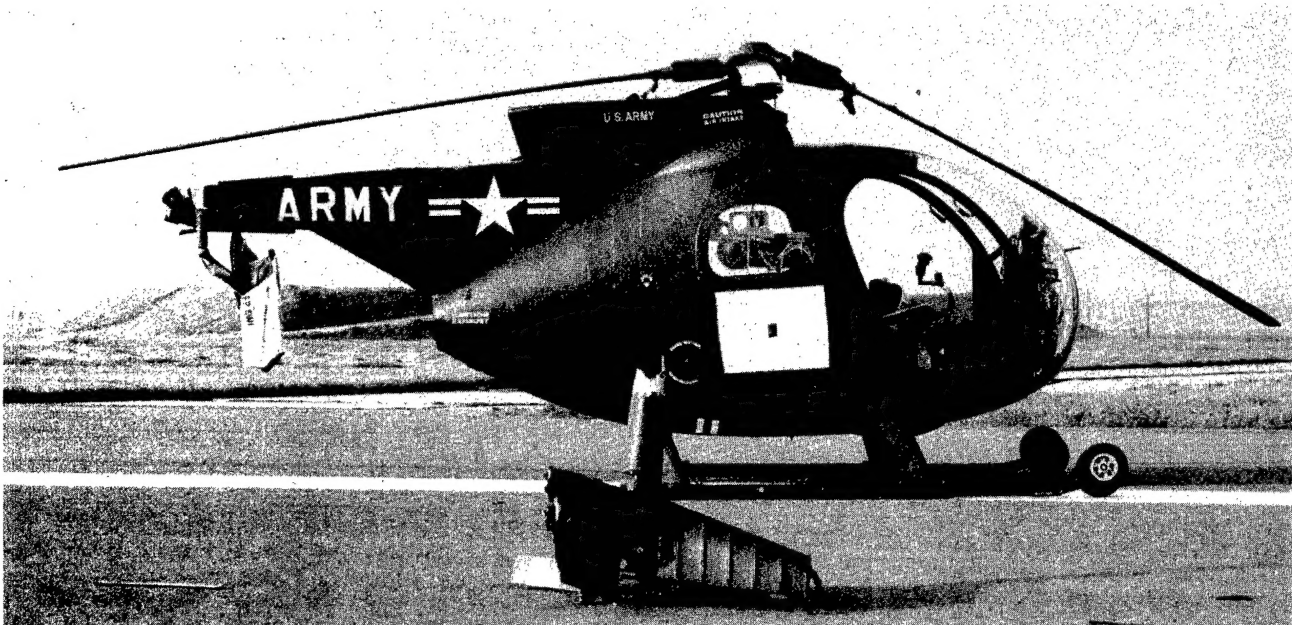
E252

E252—A test pilot, with a flight test engineer aboard, was making a practice autorotation. The maneuver appeared normal to the pilot and qualified ground observers. The helicopter touched down in a near level attitude with minimum forward speed. Immediately after touchdown, a main rotor blade struck the tail boom, severing the tail section and damaging the main rotor. The landing was made on a smooth hard surface runway. The helicopter slid approximately 14 feet from the point of touchdown and turned 20° to the left of the runway heading. The engine was

shut down and the main rotor allowed to stop before the crew got out.

CAUSE—Pilot technique of immediately lowering collective and applying aft cyclic control after touchdown, coupled with the sink rate, slight nose high attitude, and low rotor rpm, resulted in the main rotor striking the tail boom.

RECOMMENDATIONS—The board recommended: 1. A timely analysis of available data be accomplished to identify possible problem areas for future testing. 2. A means of determining clearance between the rotor blades and fuselage be employed when conducting tests of this nature. 3. A more accurate means of providing the pilot with information on absolute altitude and wind be incorporated in future testing involving critical maneuvers. 4. A warning type paragraph be included in the OH-6A Pilot's Handbook concerning the possibility of the main rotor blade striking the tail boom during autorotative maneuvers.

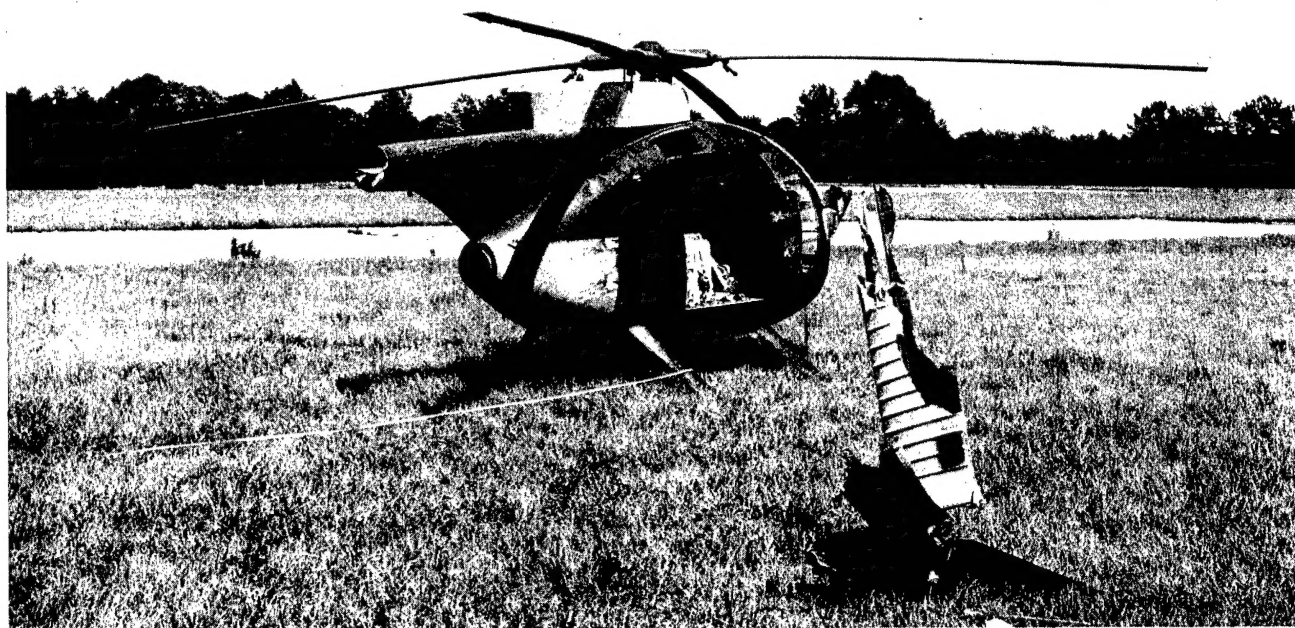
67051220

67051220—The IP and pilot took off with a gross weight of 2,340 pounds, 60 pounds under maximum gross weight. The accident occurred during a practice touchdown autorotation after 30 minutes of flight. The autorotation was made to the sod area between two runways. The aircraft landed in a tail low attitude. When it rocked forward, the main rotor blades

flexed down and severed the tail boom. The empennage arced upwards and forward into the main rotor disc. Skid marks on the ground showed the aircraft slid 55 feet after touchdown. It came to rest in an upright position on a heading of 130°, 10° left of the runway heading.

CAUSES—Instructor pilot allowed aircraft to land tail low. He did not demonstrate procedure for autorotations with loads before allowing pilot to practice autorotation with load. Probable factors were: Skid shoes used on the OH-6A create excessive drag on sod touchdowns. Main rotor blade clearance over the tail boom is less than desired.

RECOMMENDATIONS—The board recommended: 1. All instructor pilots be directed to comply with the printed syllabus of instruction. 2. The OH-6A Standardization Guide, paragraph 2, lines 3-34, and TM 55-1520-214-10, be reviewed to determine whether the operating techniques now used are satisfactory for the aircraft. 3. An improved skid shoe be designed for the OH-6A. 4. A positive safety latch be developed and installed on OH-6 engine access doors. 5. An engineering study be conducted by higher headquarters to establish a minimum safe blade clearance over the tail boom that can be measured by ground crewmen on a periodic basis.

The following actions relating to the above have been initiated: 1. All OH-6A helicopters have been equipped with smooth skids. 2. An EIR project has been established and the manufacturer is presently developing an Engineering Change Proposal (ECP) to provide improved engine compartment door hinges and positive safety latches. 3. Urgent TB 55-1520-214-20/9, 22 May 67, required an immediate inspection to determine rotor blade droop angle. If the blade droop is more than 6°, washers are installed on three bolts between spacer and striker strip, to adjust droop to range from 5° to 6°. 4. A probable or suspected cause factor that should be considered in this accident is the execution of a practice touchdown autorotation at near maximum gross weight at a high (2,550 feet) density altitude and in a crosswind. Combined, these elements reduced the margin for error.

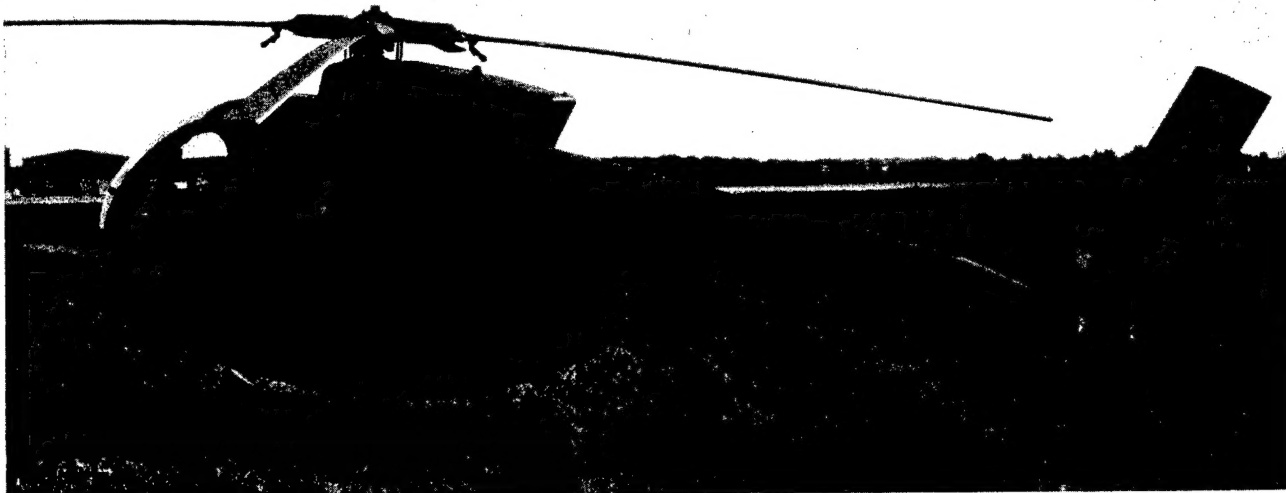
67052402

67052402—Engine instruments indicated normal on

final for practice 180° autorotation. The pilot started his flare at approximately 60 feet and made his initial pitch pull at 10-15 feet. He then cushioned his touchdown with additional pitch. It appeared smooth and normal. As the aircraft neared the end of its ground slide, the engine reportedly surged. Collective pitch was approximately two-thirds to three-quarters of the way in the up position at this point. At the same time as the reported power surge, the aircraft became airborne and began turning rapidly to the right. The IP took control and applied full left pedal, with no apparent response. The aircraft continued to spin before striking the ground on the left rear skid in a tail low attitude. The tail boom skid hit the ground, twisting the tail boom, and causing the tail rotor to strike the ground. The aircraft bounced into the air and continued to turn to the right. The throttle was checked to insure it was in the flight idle position, but the engine continued to accelerate. The IP reduced collective in an effort to land. The aircraft landed hard, skid heels first, still turning to the right and moving slightly to the rear. It came to rest upright.

CAUSE—The most probable cause of this accident was the instructor pilot or pilot inadvertently applying power during the completion of the autorotation, causing the aircraft to become airborne and uncontrolled.

RECOMMENDATIONS—The board recommended: All pilots be cautioned that it is imperative for the throttle twist grip to be held against the idle stops during pitch application for termination of autorotations and that the collective pitch must be full down prior to adding power during all ground roll operations.

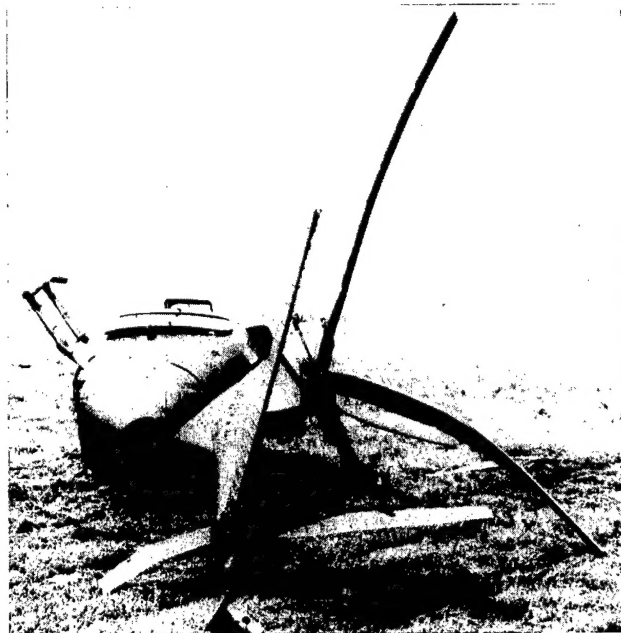
67052503

67052503—The test pilot had been flying for 3 hours, compiling data to verify the height-velocity curve at gross weights of 2,200 and 2,400 pounds. The next phase of testing was started with a change of autorotation entry, airspeed, and time delay. These changes were 30 knots airspeed with a 1-second time delay. Two autorotations, using the above criteria, were made by the copilot. He was not satisfied with the results because he felt they were marginal. The pilot did not consider the copilot's method of acceleration to the desired 50 knot flare speed as the best procedure because he felt the approach angle attitude was too steep. The pilot then entered autorotation at 200 feet agl, indicated airspeed of 30 knots, and a 1-second time delay prior to flight control

movement after chopping the throttle. A lesser dive angle was used to accelerate to the required 50-knot flare speed. This airspeed was never attained. An attempt to flare at an indicated airspeed of 47 knots was discontinued at near level attitude when it was noted that the usual buildup which accompanies the flare was not apparent. The sink rate was high and not abating, so the pilot immediately leveled the helicopter and applied partial collective pitch and full throttle. These actions slowed rate of descent slightly. The aircraft struck the ground in a level attitude with an approximate forward airspeed of 40 knots, fracturing all four landing gear struts. The left skid completely separated, causing the aircraft to pivot to the left more than 360°. It came to rest on its left side.

CAUSE—The cause was determined to be pilot

technique, while operating in the extremely hazardous area of the height-velocity curve. This technique resulted in an extremely high sink rate. The pilot then attempted an abort. However, recovery was started too late to prevent ground contact.

RECOMMENDATIONS—The board recommended: When test pilots are to determine a helicopter's height-velocity curve, extreme care should be exercised when approaching this critical curve area. Operation in the critical area of the curve should

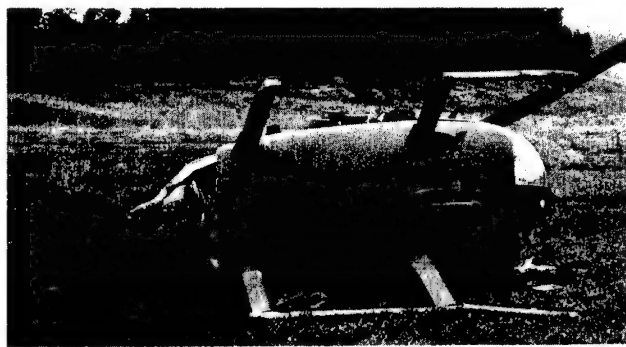
67061507

67061507—The aircraft was returning from a training flight for refueling. Nearing the airfield, the pilot started a descent. As he did, the rotor and engine rpm increased toward the red lines. The pilot increased collective, called his wingman, and informed him of the difficulty. As he lowered collective to start the approach, the engine and rotor rpm began to increase again. The pilot continued to lower collective to approximately 23 pounds of torque. The aircraft leveled off at 20-30 feet and would not descend. A go-around was made. On the second ap-

proach, the pilot used the governor control beep switch and beeped the engine to low range for 10 seconds. He then began the approach by lowering collective. The engine and rotor again went to 110% and 514 rpm and the aircraft would not descend. On the third approach, the pilot used the same technique of keeping the engine down to low range and also closed the throttle to the ground idle position. Again, the aircraft would not descend. On the fourth approach, the pilot attempted to get as low as possible before reaching the field. As he started the approach with the engine beep at low range and throttle closed to ground idle position, the engine and rotor rpm started increasing and the aircraft began a slow climb. The pilot lined the aircraft up with the runway, completely closed the throttle, and entered autorotation. Rotor rpm on entry was 520, altitude was 20-30 feet, and airspeed approximately 40 knots. The pilot began a slight flare at approximately 12 feet and pulled pitch at approximately 6 feet. The aircraft touched down heels low and slid 32 feet before becoming airborne again. During the ground slide, the yellow main rotor blade struck the top of the tail boom, causing it to snap violently. This snap caused the coupling between the tail rotor drive shaft and tail rotor gearbox to separate, resulting in loss of antitorque control. At this point, the aircraft became airborne, possibly from application of aft cyclic. It yawed to the right with the heel of the right skid striking the ground. The red and black blades struck the tail boom and ground, causing the aircraft to spin to the left. It came to rest on its left side.

CAUSES—Engine and rotor overspeed due to failure of the fuel control governor. This failure was caused by a small piece of nylon (used as a thread locking device) lodged in the Py bleed orifice. The pilot used poor judgment and technique in starting an autorotation at low altitude and airspeed in the caution area illustrated by the Flight Envelope Curve Chart in TM 55-1520-214-10. Supervisory error was evident on the part of the IP at ground control for advising the low shallow approach.

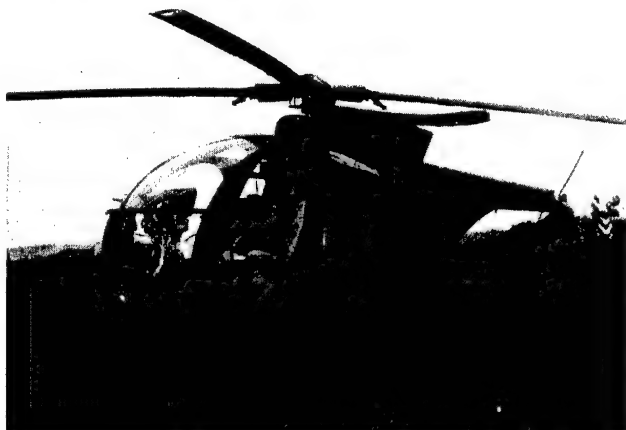
67062708

CAUSES—IP allowed the pilot to hold centered or slightly aft cyclic during initial touchdown, with possible further aft cyclic movement after touchdown. This, combined with full collective travel prior to touchdown, caused a harder than normal touchdown. Low rotor rpm resulted in the main rotor striking the doghouse and tail boom.

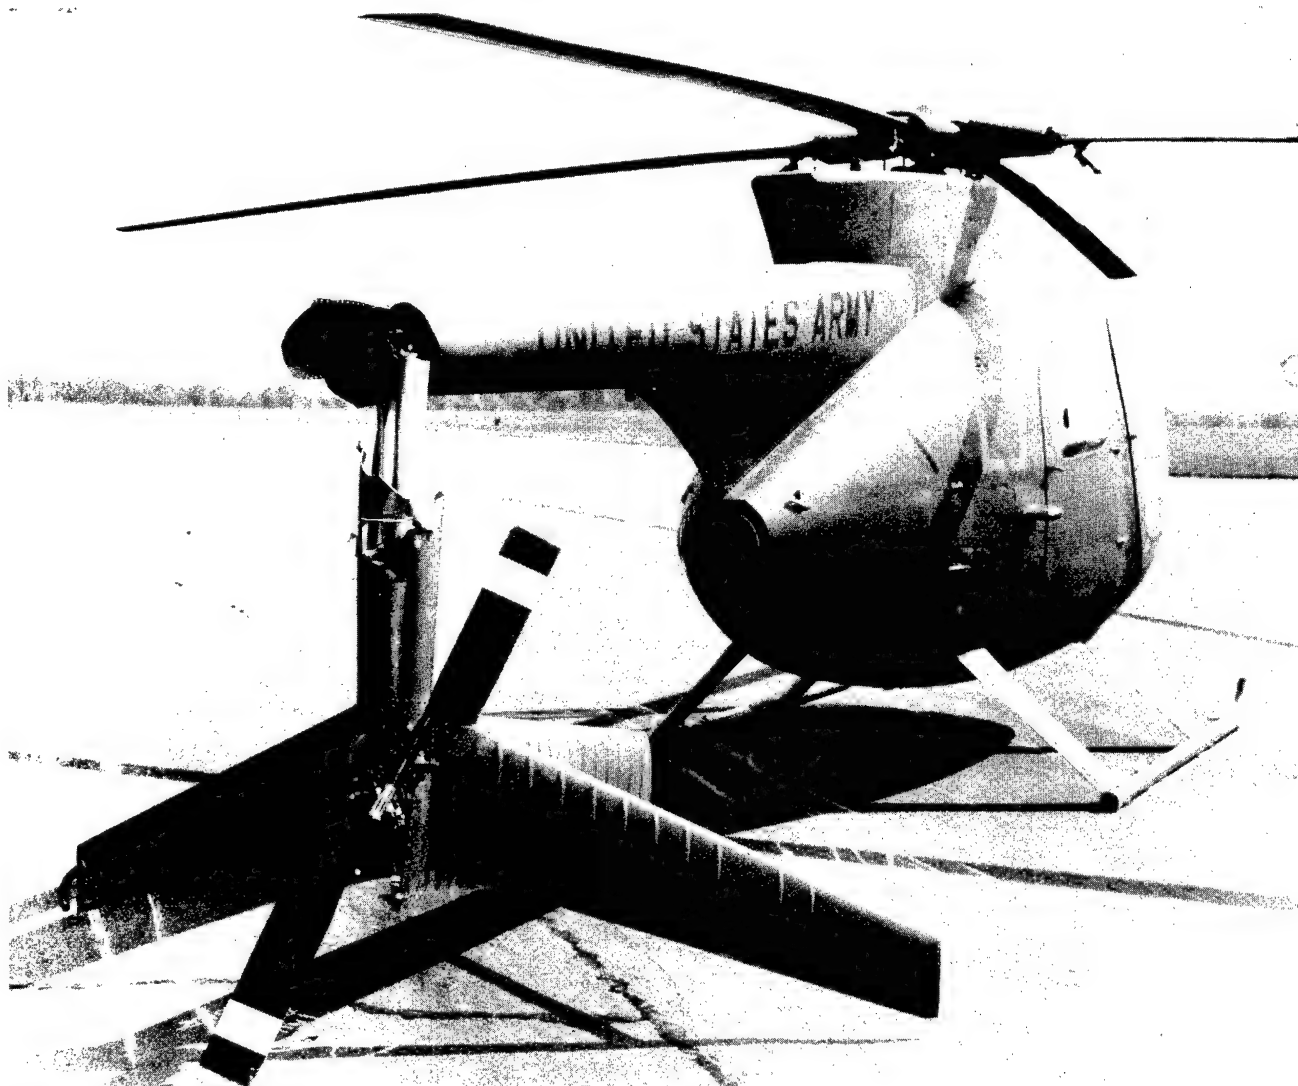
67063003

67063003—After flying 1 hour with one pilot, the IP landed and picked up another pilot without shutting down the helicopter. Six hovering autorotations were made. IP requested and received permission to use the active runway for autorotations because the sod area was too wet. He then let the pilot attempt a straight-in autorotation, entering at 500 feet. Normal deceleration was made to approximately 60 knots, rotor rpm was stabilized in the green, and a decel-

erative flare was started at 50-75 feet. Initial pitch was applied at approximately 10 feet. The right skid struck the ground at approximately 5 knots forward speed. The helicopter skipped off the ground and left cyclic was applied. Shortly after initial ground contact, the red main rotor blade struck the tail boom, partially severing it. Directional control was lost and the helicopter slid 27 feet from point of initial contact, turning approximately 43° to the right. The engine continued to run and was shut down by the crew.

CAUSES—The static main rotor blade droop angle was 1° out of tolerance due to inadequate inspection. It was suspected that the pilot landed slightly tail low with low rotor rpm, allowing the main rotor blade to flex down and strike the tail boom.

RECOMMENDATIONS—The board recommended: 1. Rigid inspection requirements of the OH-6A static droop angle to prevent recurrence. 2. Acceptance facilities establish procedures to insure the static droop angle is correct before aircraft are accepted and assigned to units. 3. Paragraph 3-34, TM 55-1520-214-10, be changed to include a warning about
